Quality Assurance and Source Inspection

Contract #: 04-0120F4Cty: SF/ALA Rte: 80 PM: 13.2/13.9File #: 69.28**WELDING INSPECTION REPORT****Resident Engineer:** Pursell, Gary**Address:** 333 Burma Road**City:** Oakland, CA 94607**Report No:** WIR-009856**Date Inspected:** 21-Oct-2009**Project Name:** SAS Superstructure**OSM Arrival Time:** 645**Prime Contractor:** American Bridge/Fluor Enterprises, a JV**OSM Departure Time:** 1845**Contractor:** Zhenhua Port Machinery Company, Ltd (ZPMC), Changxing Island **Location:** Shanghai, China**CWI Name:****CWI Present:****Yes No****Inspected CWI report:** **Yes No N/A****Rod Oven in Use:** **Yes No N/A****Electrode to specification:** **Yes No N/A****Weld Procedures Followed:** **Yes No N/A****Qualified Welders:** **Yes No N/A****Verified Joint Fit-up:** **Yes No N/A****Approved Drawings:** **Yes No N/A****Approved WPS:** **Yes No N/A****Delayed / Cancelled:** **Yes No N/A****Bridge No:** 34-0006**Component:** OBG Segment**Summary of Items Observed:**

OBG # TRIAL ASSEMBLY YARD (1AAE-1AE)

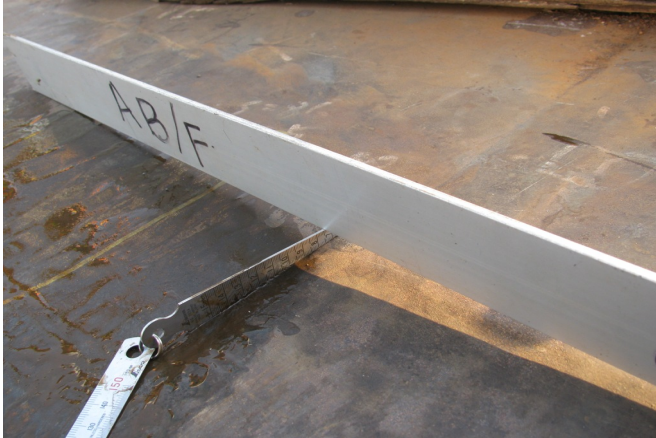
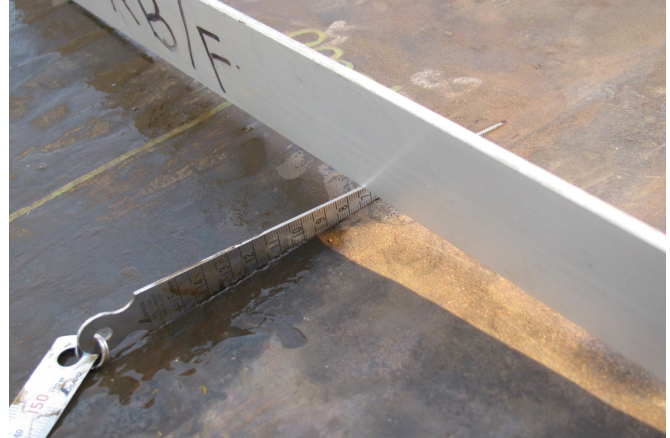
Caltrans Quality Assurance (QA) inspector observed at the Deck Panel for skin flatness at 1AAE to 1AE segment near transverse splice weld joint OBE1-001 (Location 16 to 16.5m of the weld joint, Whereas '0' starts Crossbeam side). The surface flatness survey data was taken on the exterior side (flat side of the weld) on the Deck Panel. The out of flatness measurement is 7mm over a length of 600mm. For further information, please see the attached pictures below.
